AIR QUALITY AND GREENHOUSE GAS EMISSIONS IMPACT ASSESSMENT

Subject: Air Quality and Greenhouse Gas Emissions Impact Assessment for the San

Diego River Trail Qualcomm Stadium Segment Project

WATER QUALITY TECHNICAL REPORT

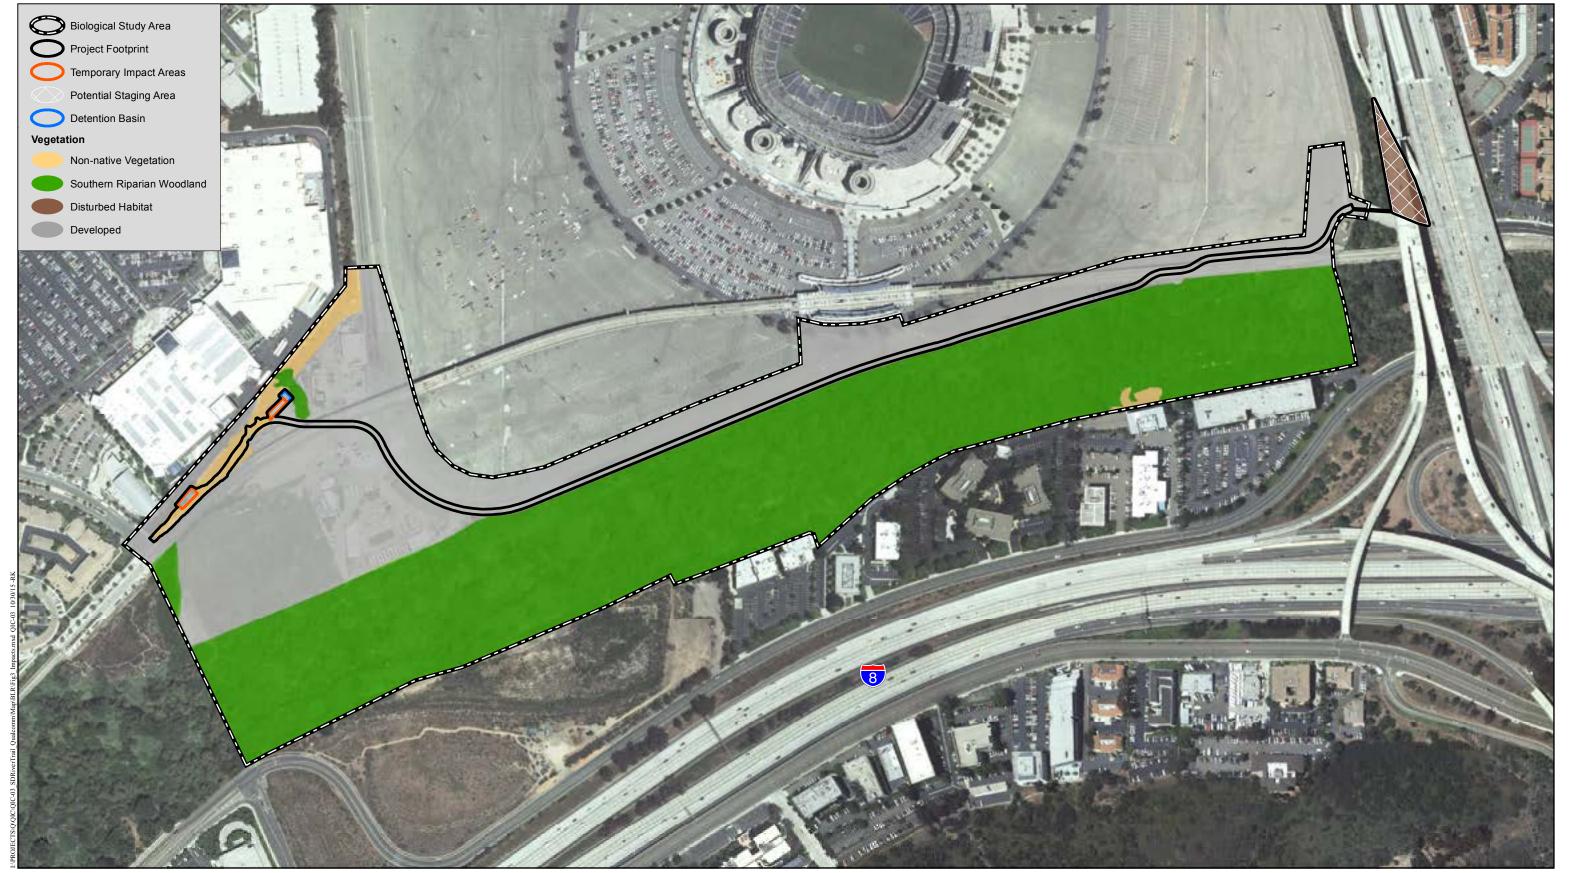
Vegetation/Impacts

In addition to developed land, the BSA is characterized by southern riparian woodland and non-native vegetation (Figure 3). A description of each vegetation community or land use type is provided below, which includes a discussion of plant species observed during the general biological survey. Table 2 provides a summary of the existing vegetation communities found to occur within the BSA, as well as project impacts (temporary and permanent) to these vegetation communities.

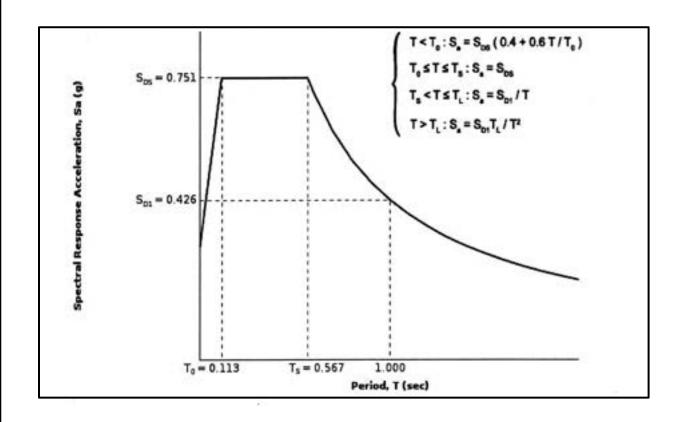
DESIGN RESPONSE SPECTRUM				
	SAN DIEGO RIVER TRAIL QUALCOMM SEGME	NT		
PROJECT NO.	ALLIED GEOTECHNICAL ENGINEERS, INC.	FIGURE 3

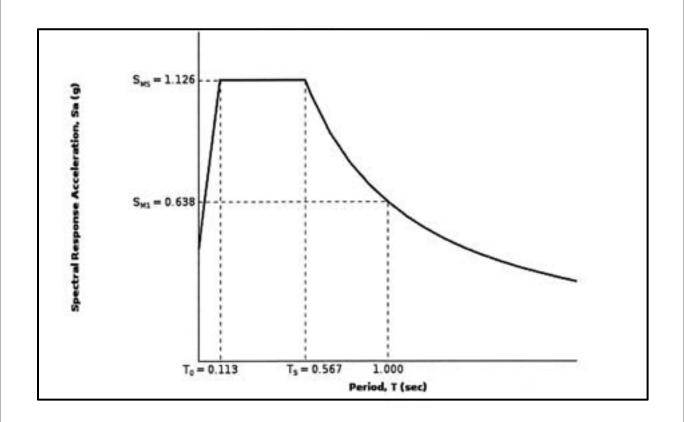
RISK-TARGETED MAXIMUM CONSIDERED EARTHQUAKE (MCE _R)
SAN DIEGO RIVER TRAIL QUALCOMM SEGMENT

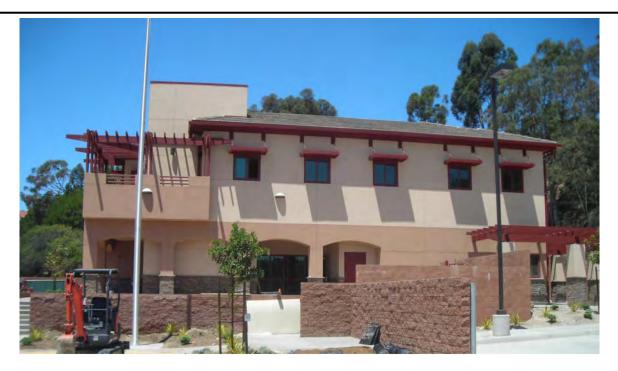
View of City of San Diego Fire Station No. 45 located at 9366 Friars Road, across from the Qualcomm Stadium. The site was identified as former Fenton property (EDR Map ID No. G-38) on the EDR Report.

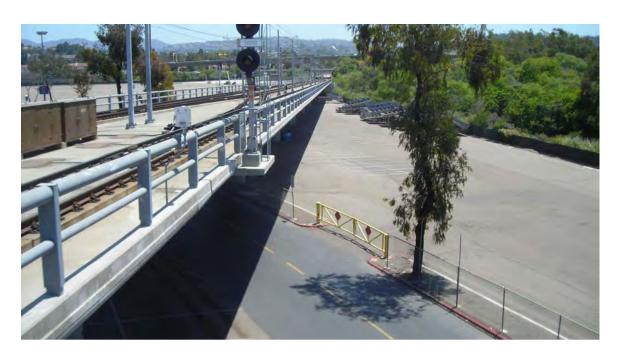
PHOTOGRAPH E-1

View looking east along the proposed project alignment from the Qualcomm Trolley Station.

The bleacher storage area is visible on the photograph.

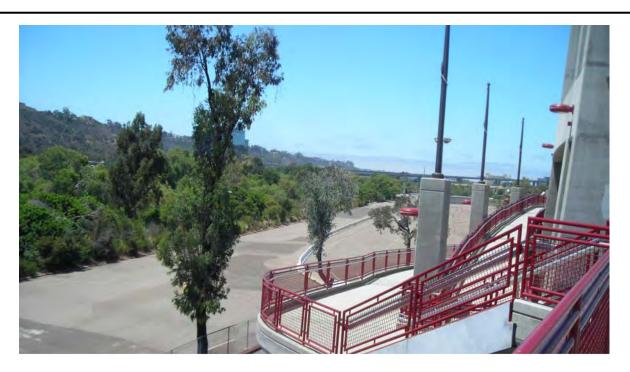
View looking west along the proposed project alignment from the Qualcomm Trolley Station.

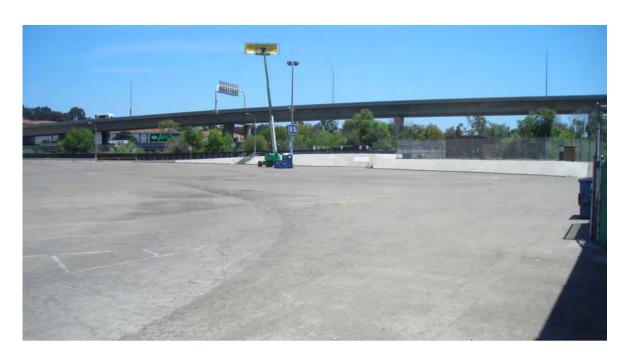
PHOTOGRAPH E-2

View of eastern terminus of project alignment with ramp connection to Rancho Mission Road.

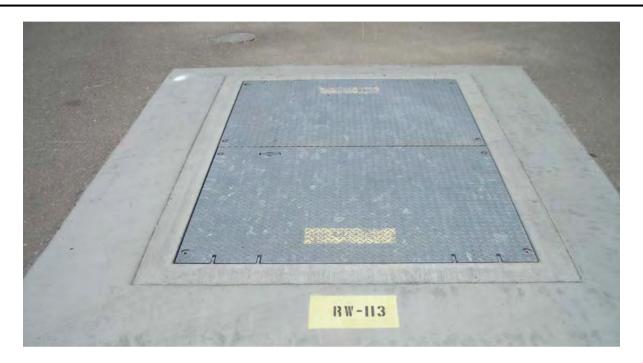
One of the numerous extraction wells located in the Qualcomm Stadium parking lot.

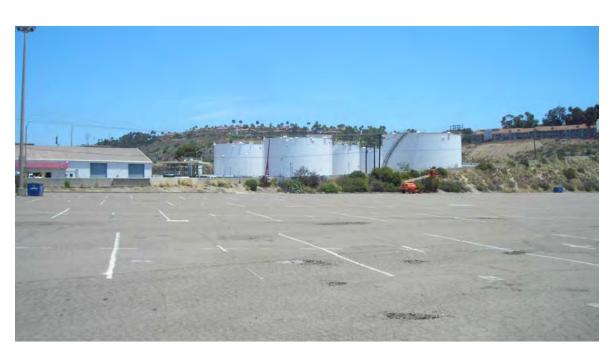
View of Kinder Morgan facility (EDR Map ID Nos. F-32 through F-37) from Qualcomm Stadium parking lot.

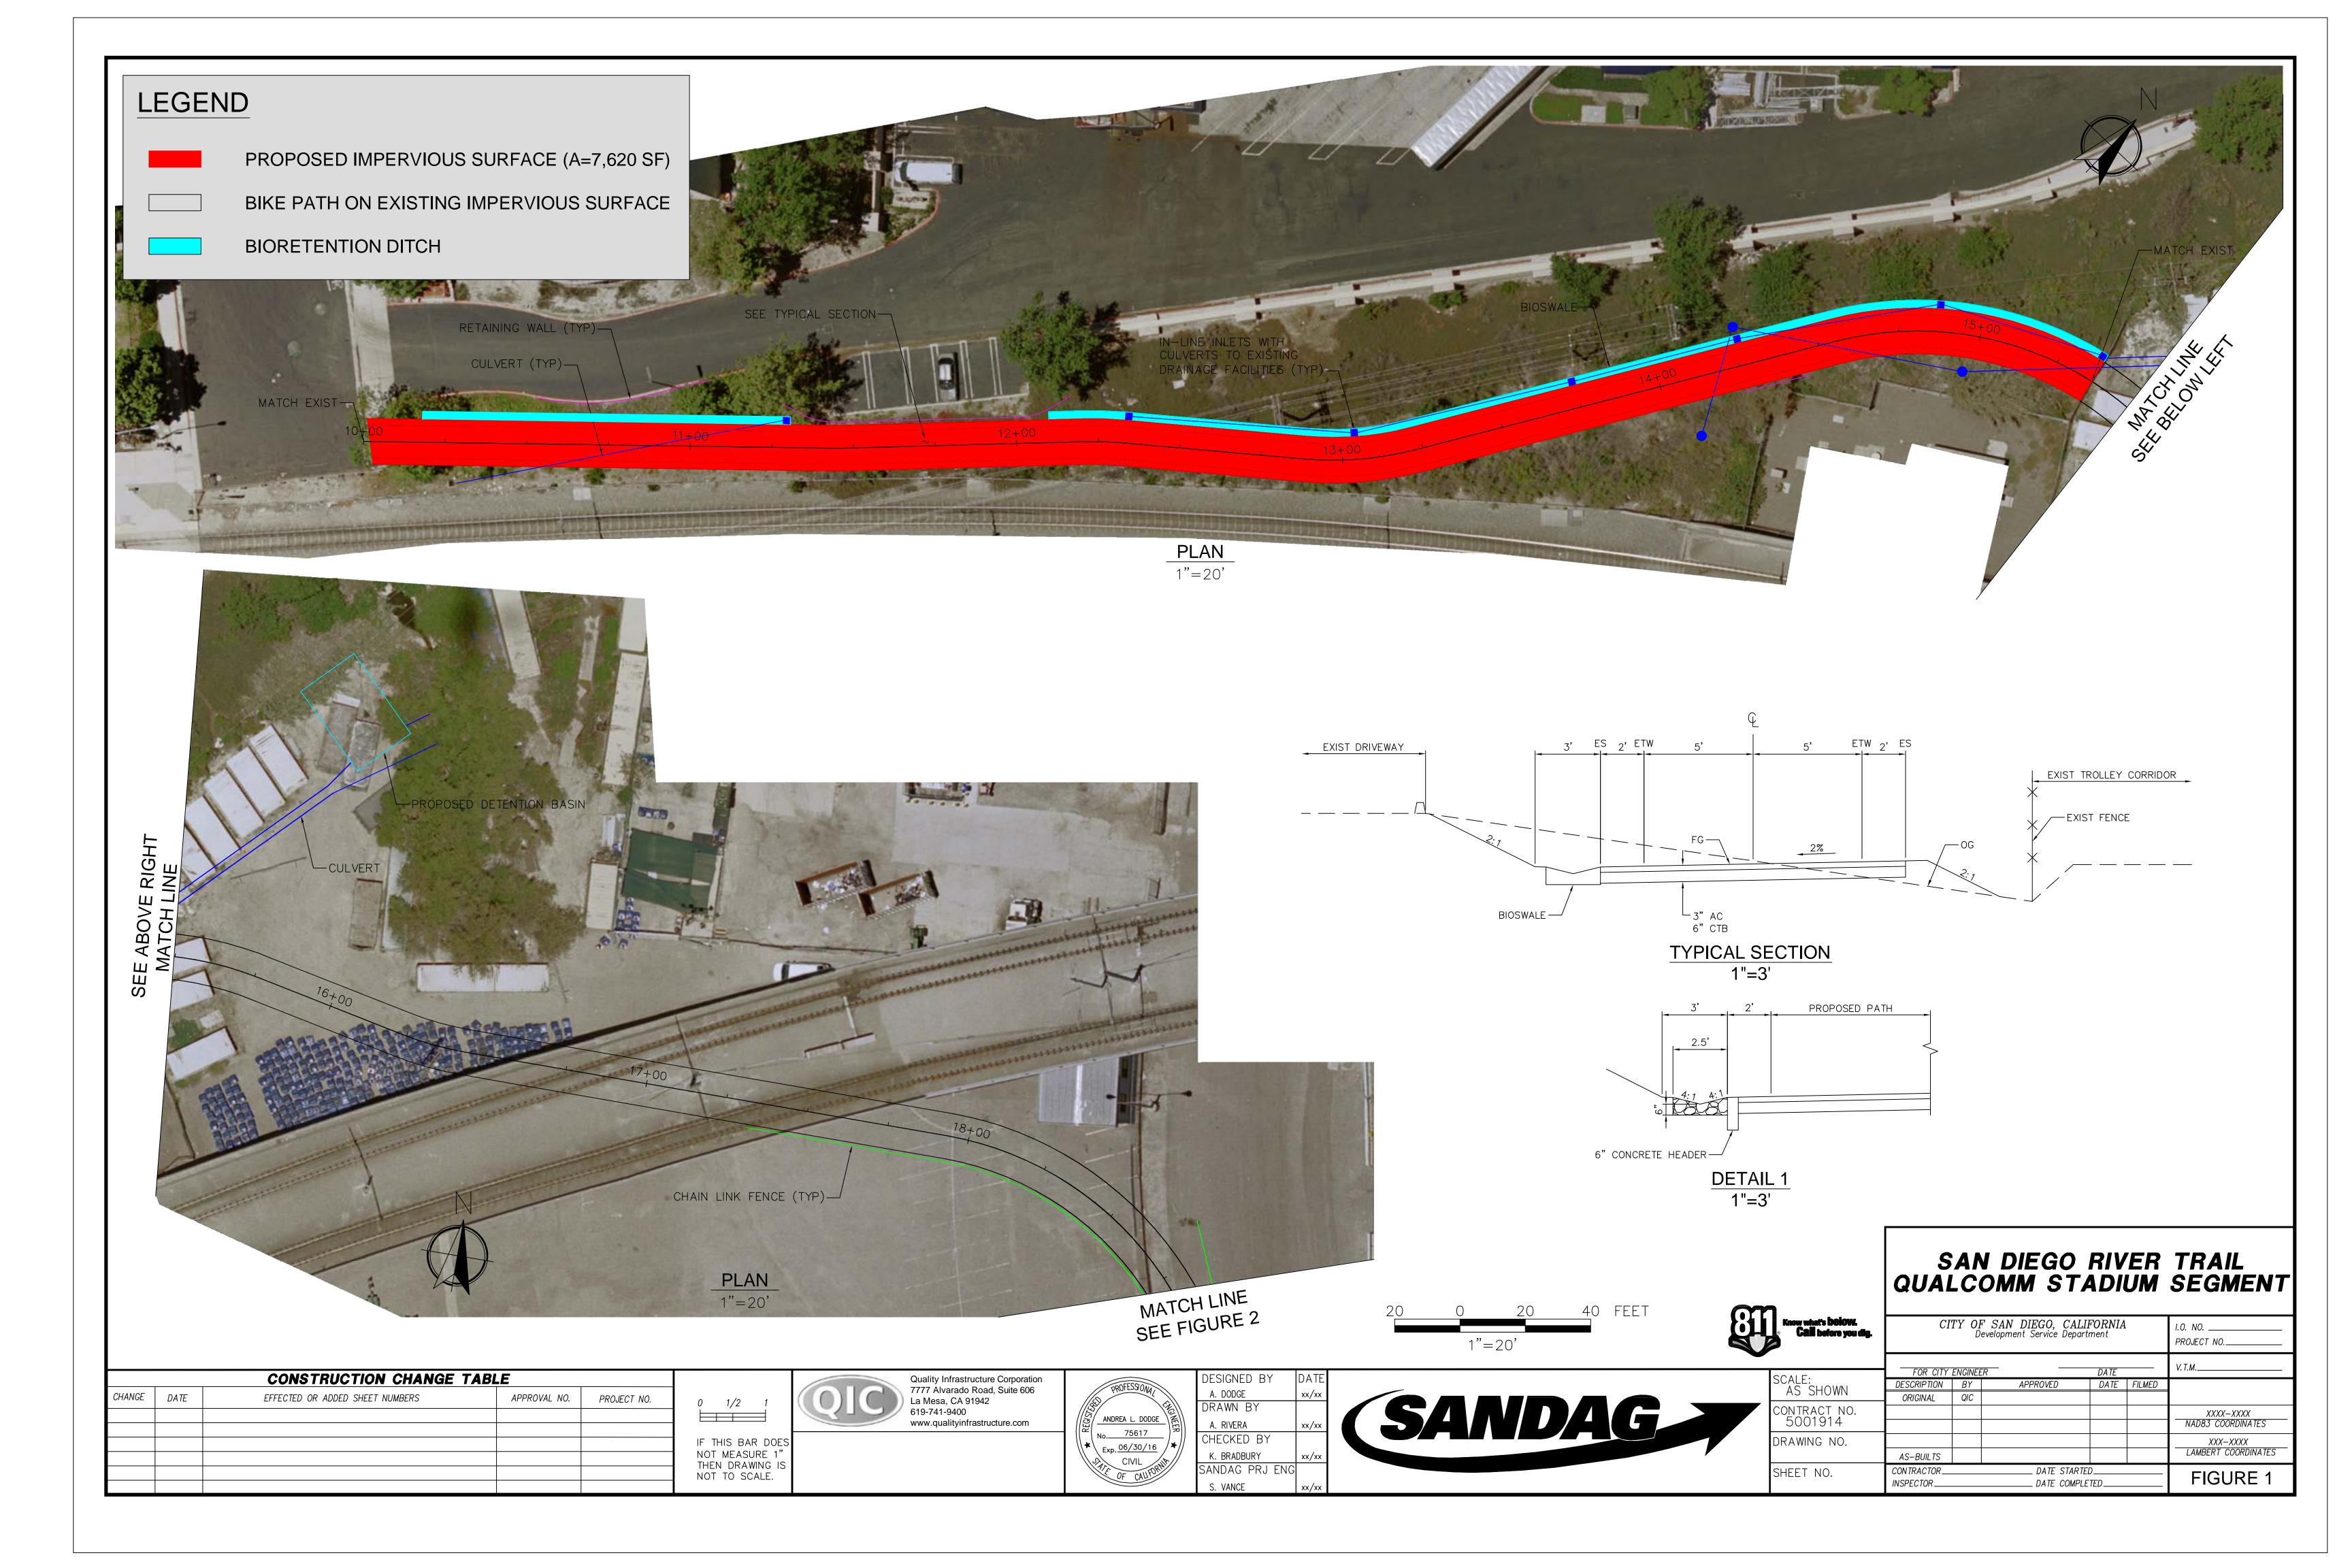
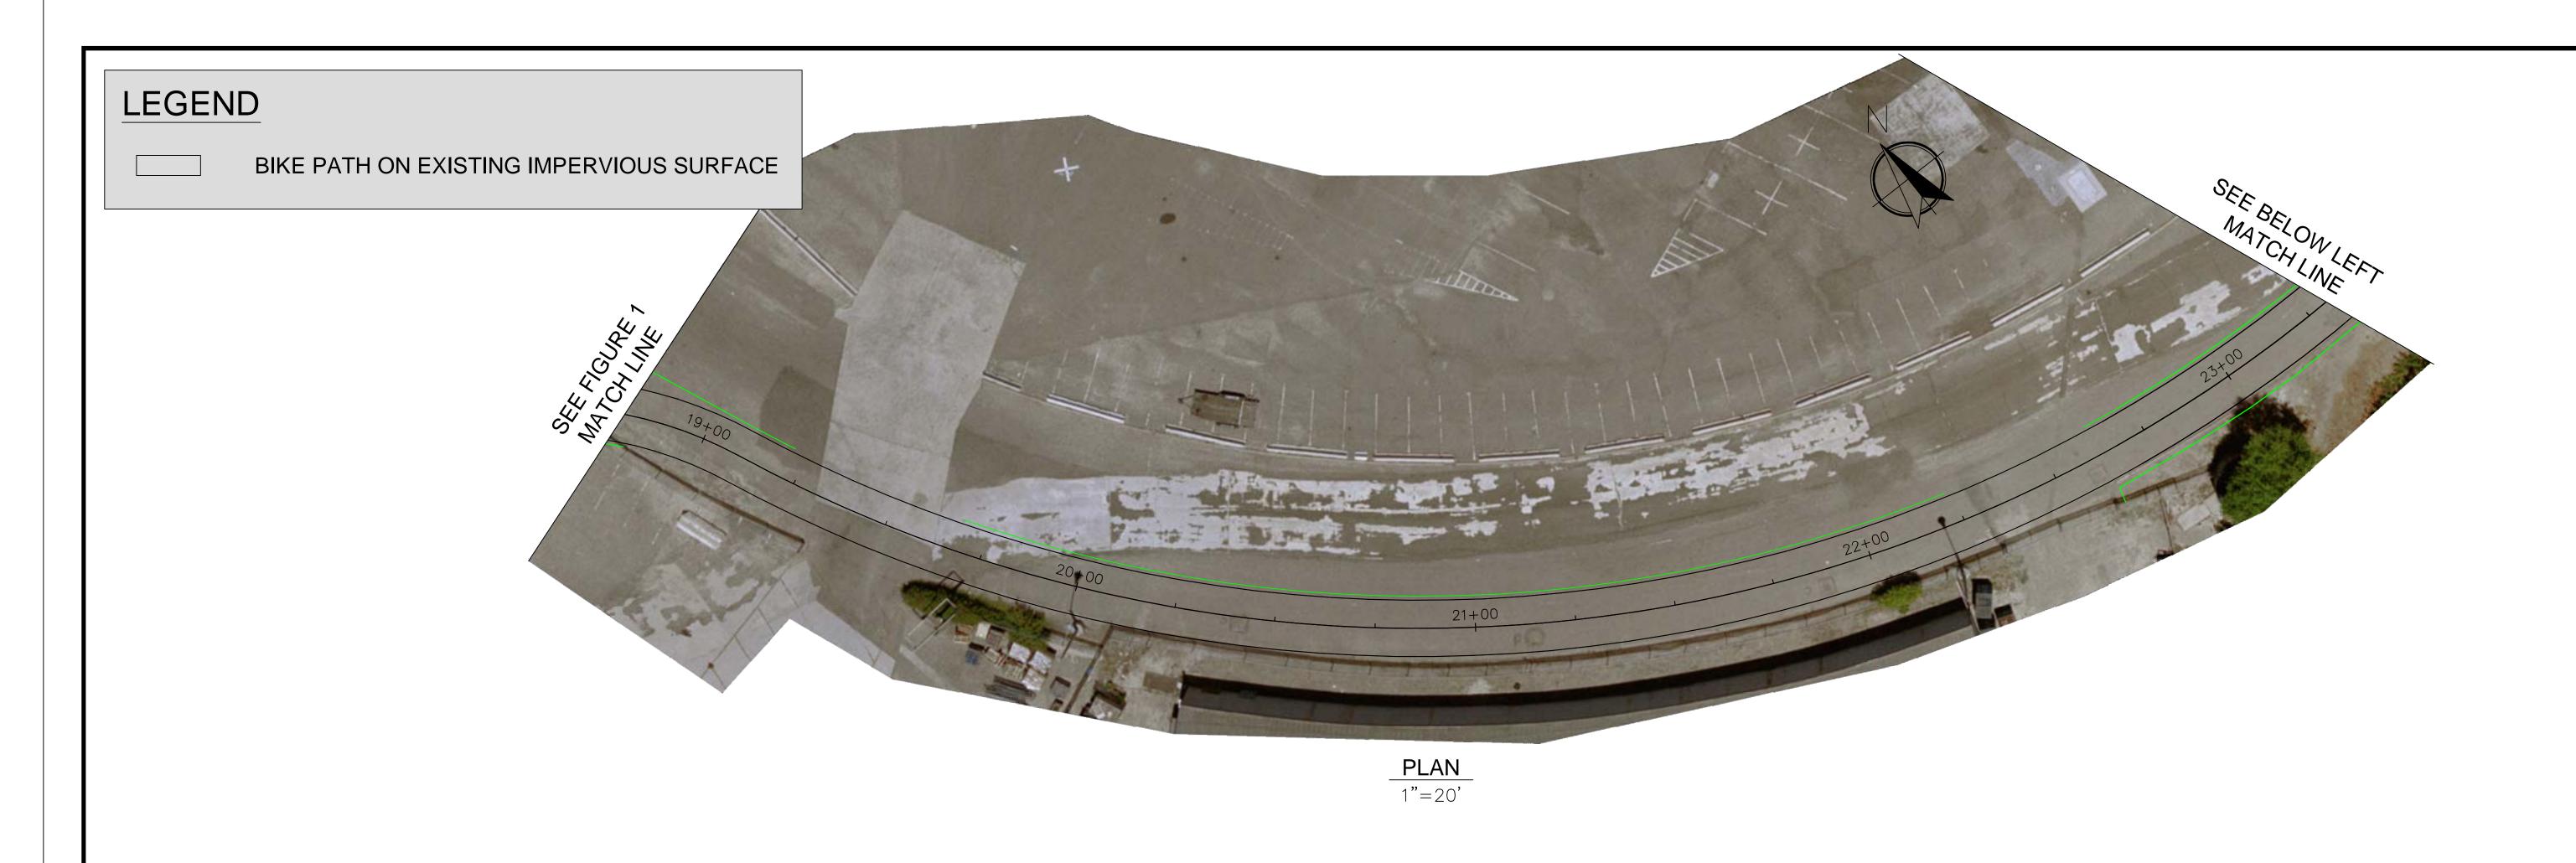
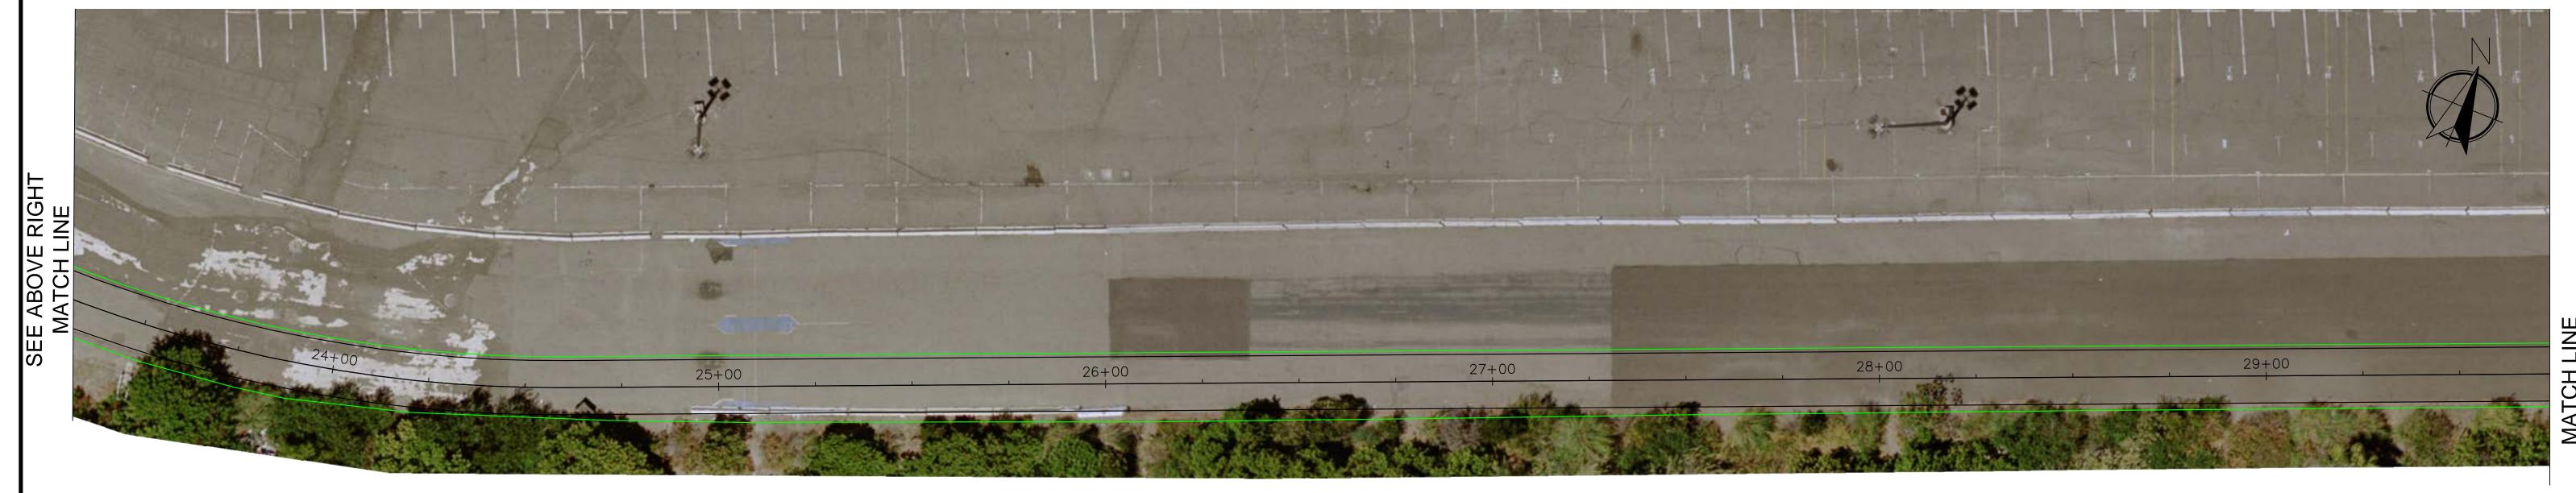
PLAN 1"=20'

San Diego River Trail – Qualcomm Stadium Segment Proposed Drainage Exhibits
